AFAPL-TR-79-2063

Build 2 of an Accelerated Mission Test of a TF41 with Block 76 Hardware

Final Report for Period 2 August 1978 - 20 September 1978

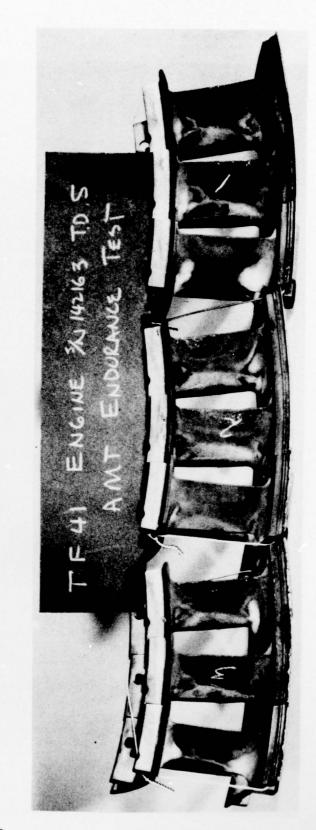
Figure 49 - First-Stage High-Pressure Turbine Vanes

- L.P. Turbine (Figure 48)
  - Some blades and vanes have light FOD damage.
- H.P. Turbine
- First stage vanes showed some cracks and distress (Figures 49 and 50).
- First stage blades one broken and five with leading edge cracks (Figures 51 thru 53).
- Second stage vanes showed light to heavy FOD and some vanes have large pieces missing from the trailing edge (Figure 54).
  - Second stage blades showed light to heavy FOD (Figure 55).
  - Burner
    - Eight primary air scoops showed crack indications.
    - All liners and nozzle assemblies showed cracks and fretting,

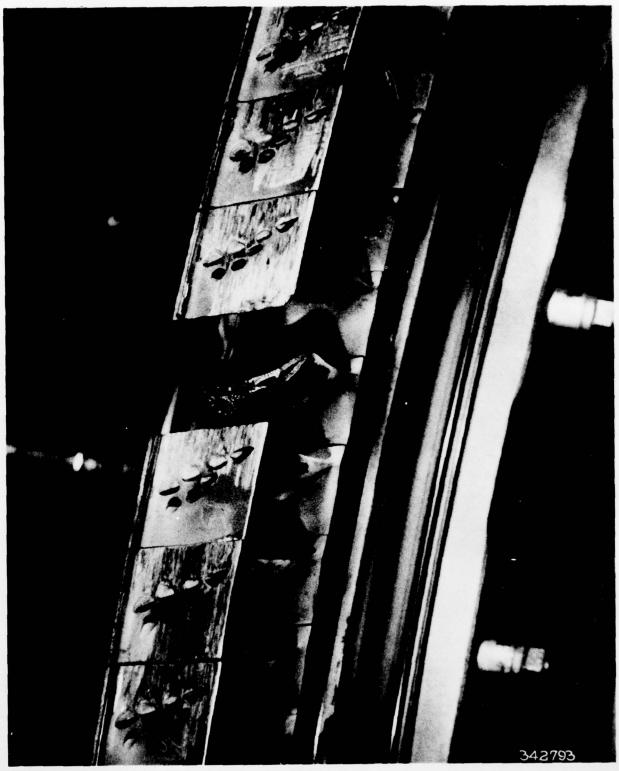
Figure 52
Failed First-Stage High Pressure Turbine Blade
85

Fluorescent penetrant inspection of the failed blade showed no additional indication of cracks or surface irregularities.

Examination of the fracture surface using the Scanning Electron Microscope showed that striations indicative of fatigue were present and progressed toward the trailing edge.
